# PUNCHLIST

Repair Estimate Prepared For

655 North Stiles Drive  
Charleston, SC 29412

## Repair Estimate

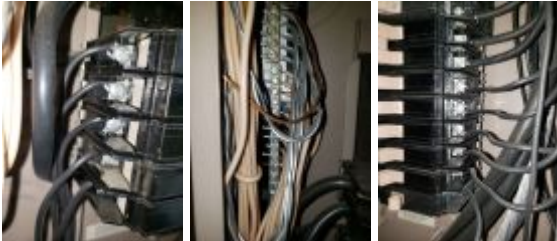
Inspection Location: Basement

Inspection Notes: There is single strand aluminum wiring present on 120V circuits. This wiring has an established history loose connections, arcing, overheating, and fires. This is a safety hazard.

»» -- Evaluate electrical system.

Price includes evaluation of issues by a licensed electrician. Price to be adjusted depending on repairs required.

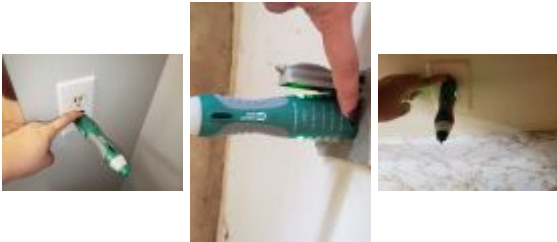
Inspection Location: Multiple Locations

Inspection Notes: There is a standard receptacle installed in a location that currently mandates a GFCI device. While this may not have been required at installation, it is a safety concern.

»» -- Replace outlet(s) with GFCI-protected outlet(s).
